NASA TECHNICAL MEMORANDUM

NASA TM-82446

PASSIVE OPTICAL SAMPLE ASSEMBLY (POSA): FINAL REPORT

August 1981

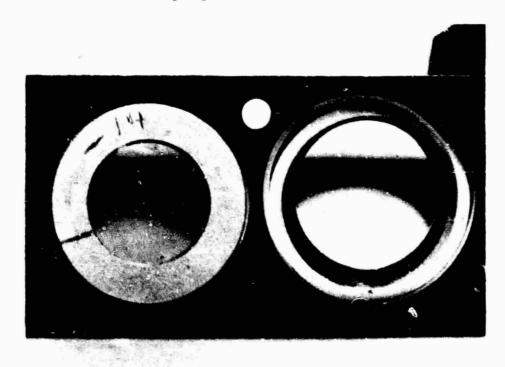
Figure 9. POSA/FF: sample positions E, F (CaF₂, electrets).
